# Remote Visual Assessment of Roofs

Buildings at Budziszynska Street in Szczecin • addresses 47b, 47c, 48, 48a, 49, 49a, 49b, 49c and 49d as identified by residents

| Field | Value |
|---|---|
| Date of issue | 14 August 2026 |
| Prepared by | Aeronautiq Drone Solutions |

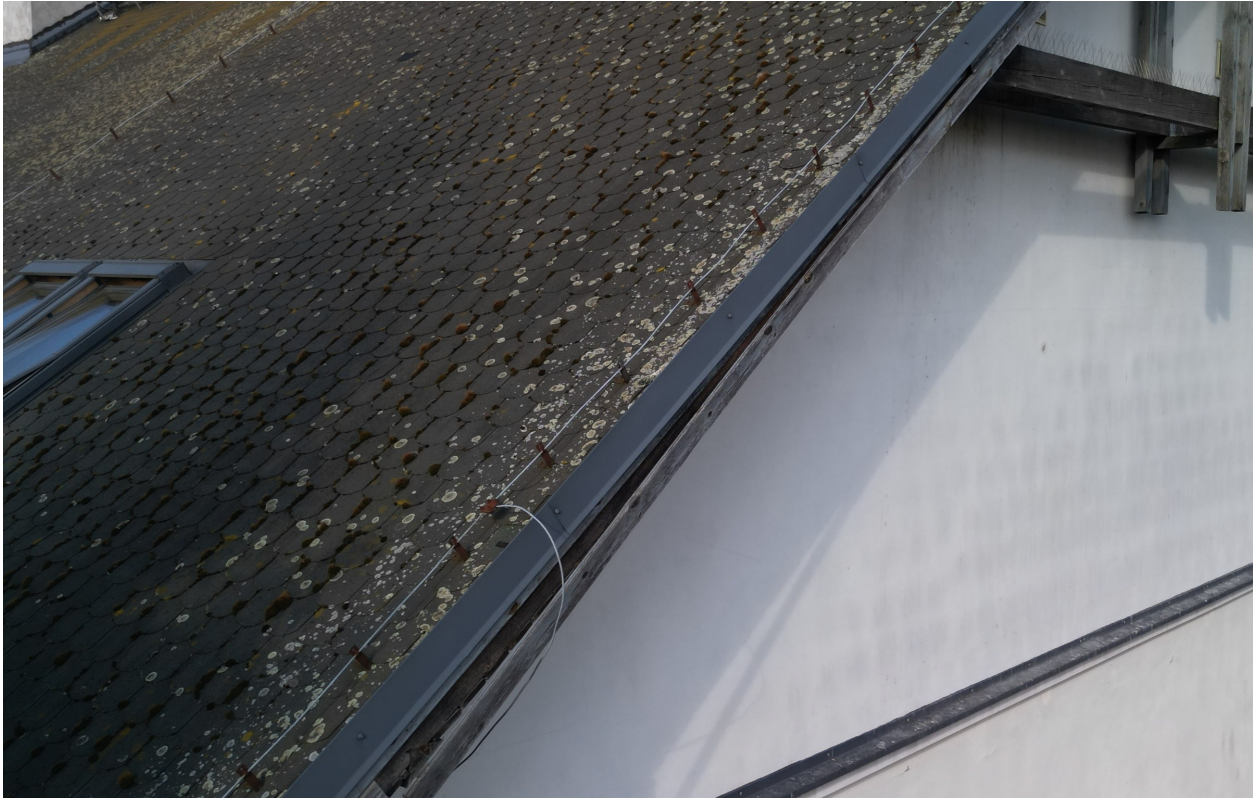
PHOTOGRAPH 01 • SOURCE DJI\_0260.JPG

**Observation:** Numerous light-coloured deposits and local raised accumulations resembling moss are visible on several roof planes, particularly at laps, edges and shaded zones.

**Observation:** Visible timber has a greyed, non-uniform surface and in places appears to lack a continuous protective coating. DJI\_0306 also shows a local discontinuity in a board at the eaves.

**Observation:** Cables or lines, brackets, access walkways and other equipment are visible. Some sections form loops or cross drainage zones. One satellite dish has extensive surface corrosion.

*Photo 01. Extensive deposits, moss-like accumulations, visible cables or lines and weathered timber.*

**Verification required:** Identify the covering and inspect it at close range. Trial a safe cleaning method on a small area; do not use aggressive washing or chemicals until compatibility and run-off management are confirmed.

**Verification required:** Carry out a hands-on inspection, moisture measurements and checks of joints and fixings. Determine refurbishment or replacement only after assessing the remaining section and possible moisture sources.

**Verification required:** Identify each element, inspect fixings and corrosion, and remove inactive equipment only after confirming its function. Do not treat visible lines or walkways as an approved safety system without the required inspection.

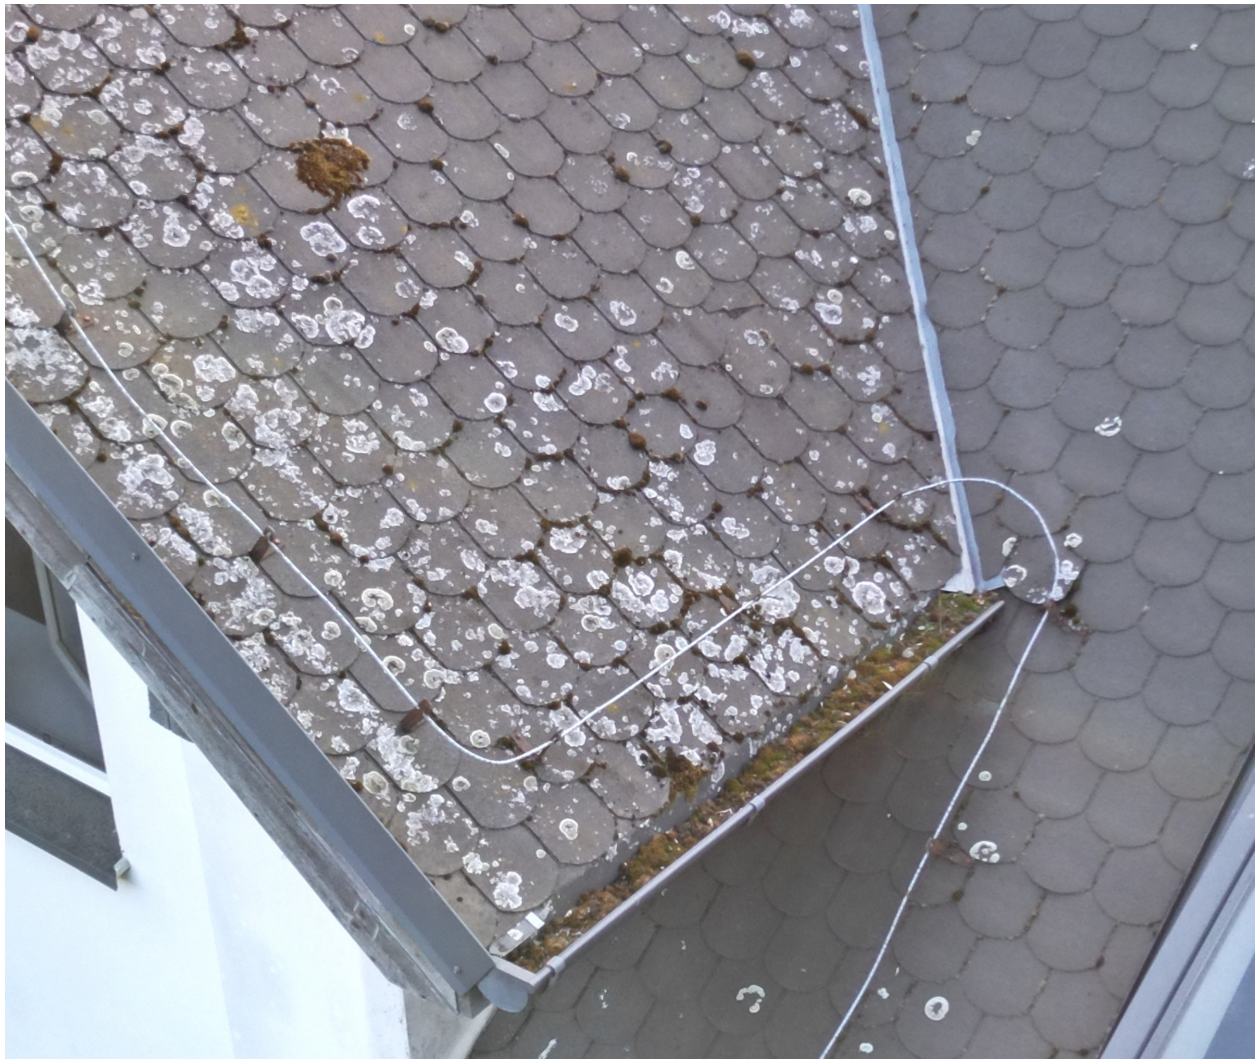
PHOTOGRAPH 02 • SOURCE DJI\_0272.JPG

**Observation:** Debris and organic material are visible at a roof junction and in a visible section of gutter. The images do not show the full gutter cross-section or downpipes.

*Photo 02. Organic material at the roof junction and a cable or line of unconfirmed function.*

**Verification required:** Clean and inspect valleys, gutters, corners, outlets, downpipes and discharge points. Carry out a controlled flow test and prepare before-and-after records.

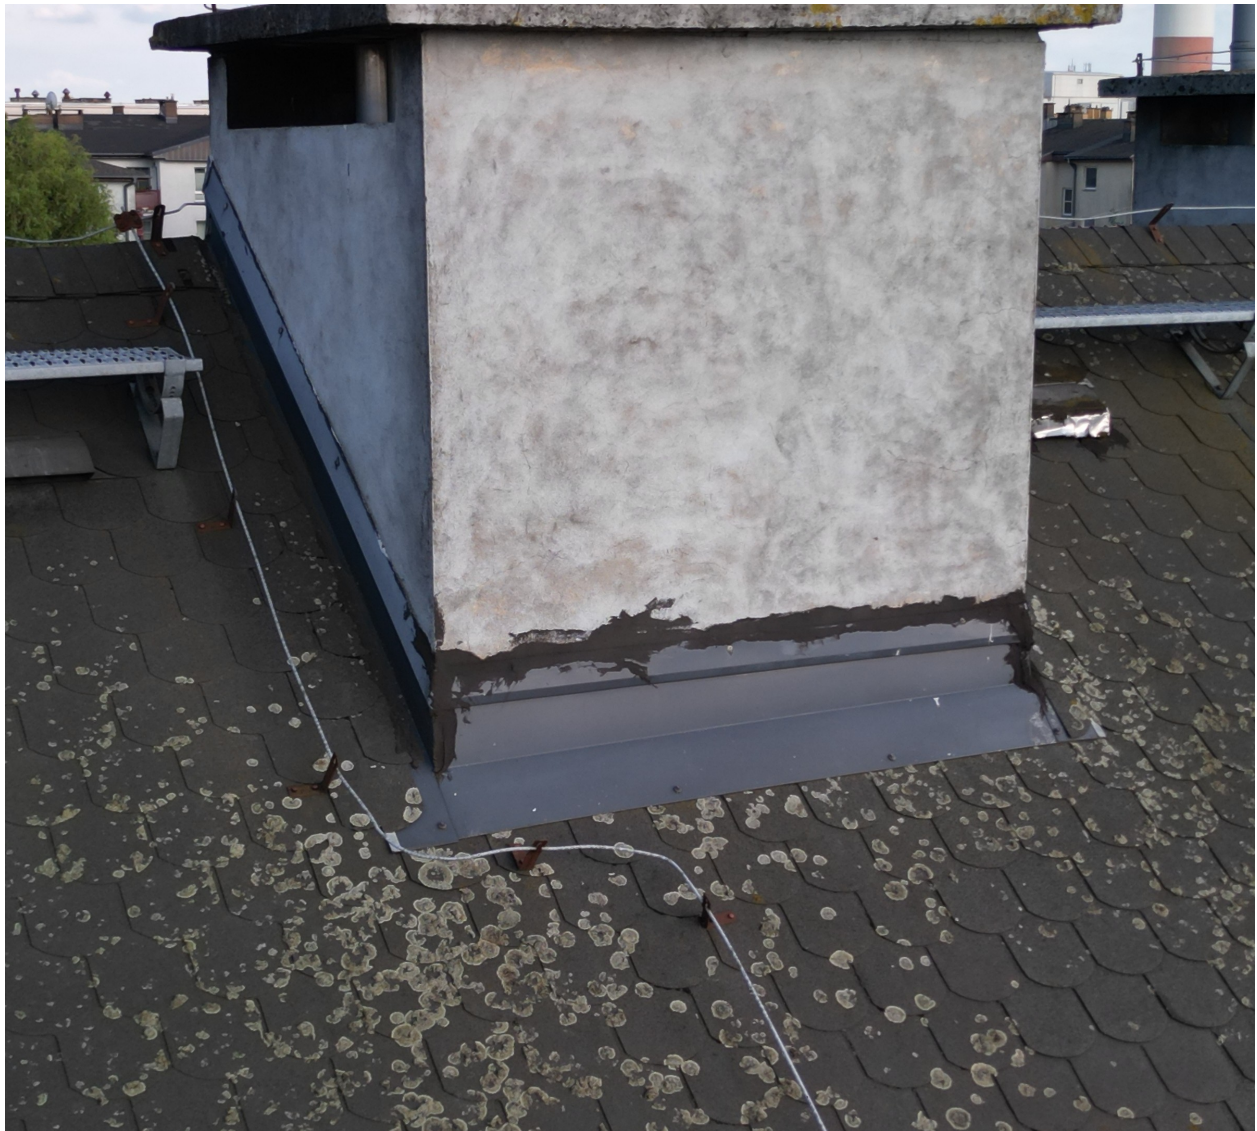
PHOTOGRAPH 03 • SOURCE DJI\_0289.JPG

**Observation:** Metal flashings and a local strip of sealing or repair material are visible at the base of the chimney. The stack and capping slab are soiled and covered with deposits.

**Possible implications:** The appearance may indicate an earlier intervention but does not itself establish leakage or chimney damage.

*Photo 03. A strip of apparent repair or sealing material is visible at the chimney base, with deposits on the covering.*

**Verification required:** Check flashing continuity and adhesion, corners, the junction with the covering, capping-slab edges, service penetrations and any signs of leakage from the attic side.

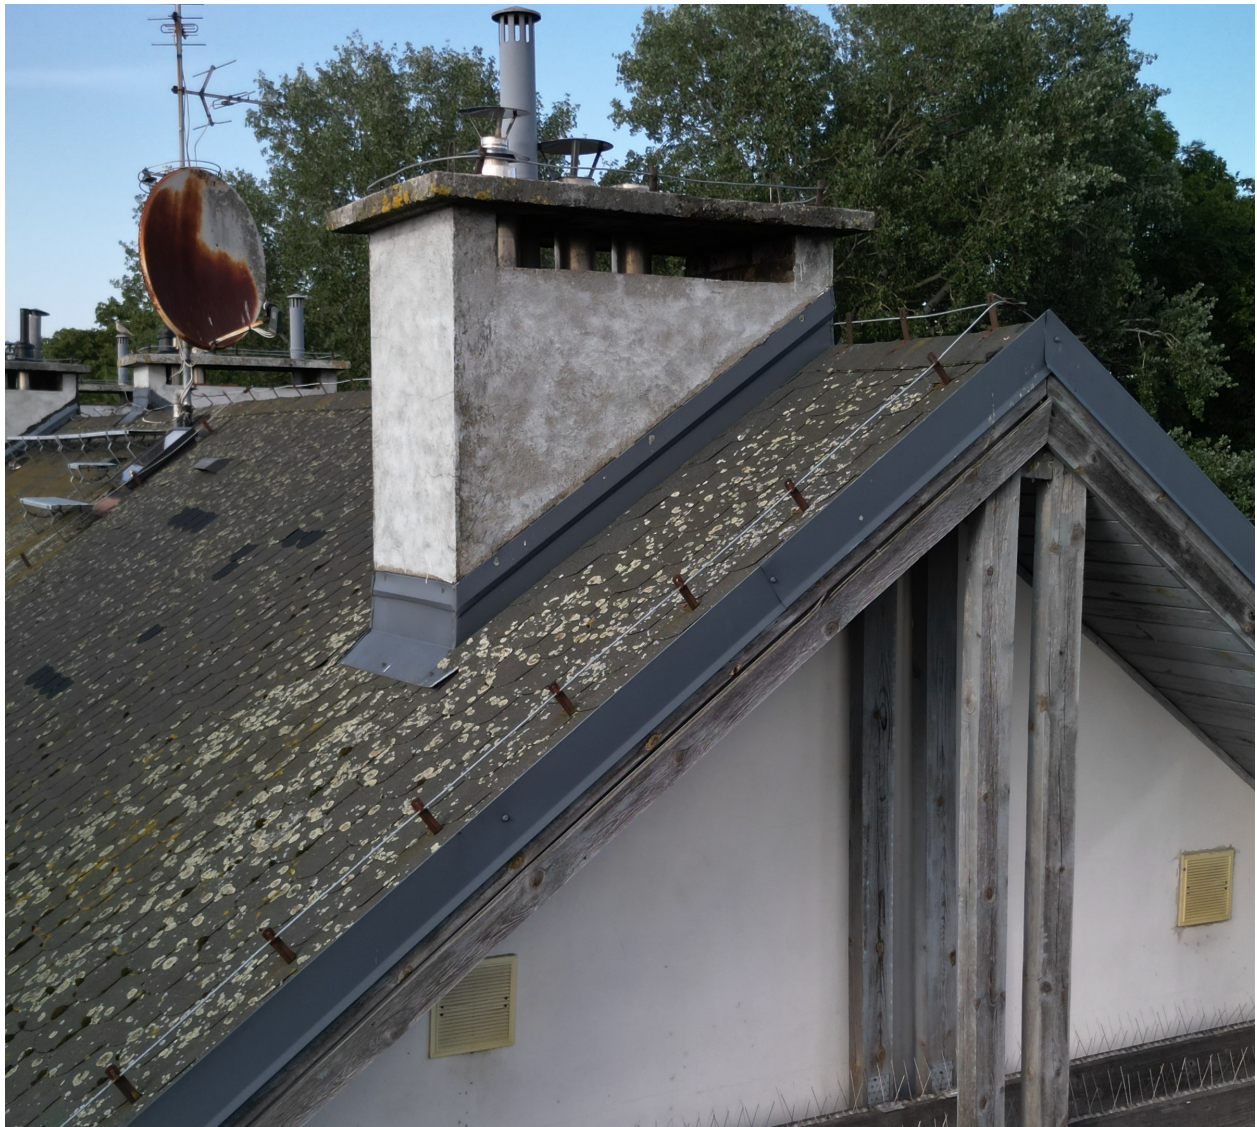
PHOTOGRAPH 04 • SOURCE DJI\_0264.JPG

*Photo 04. Extensive corrosion on one dish, deposits on the covering and chimney caps, and weathered timber.*

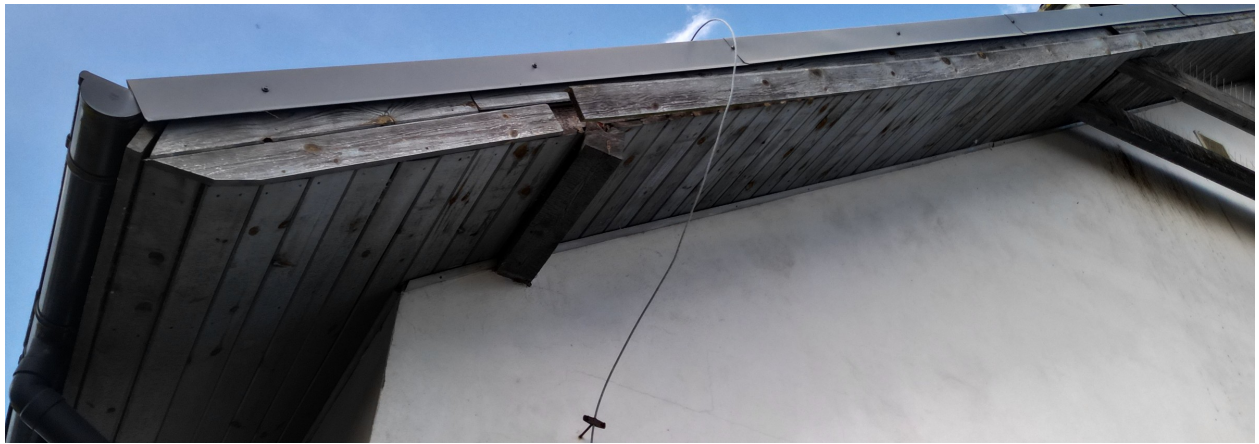
## PHOTOGRAPH 05 • SOURCE DJI\_0306.JPG

*Photo 05. A local discontinuity in a timber board at the eaves and a loosely routed cable.*

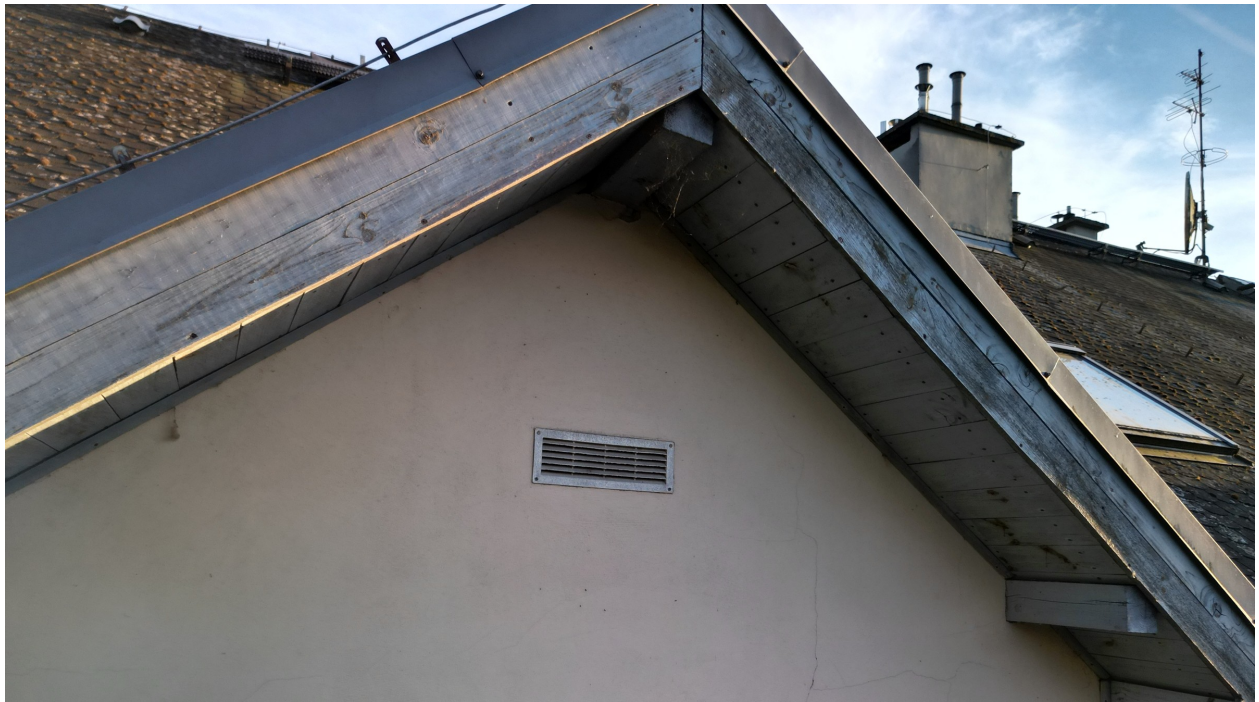
PHOTOGRAPH 06 • SOURCE DJI\_0381.JPG

**Observation:** Fine, locally branching cracks are visible in the light-coloured render below the gable. The public image is cropped so that the dwelling window is not shown.

**Possible implications:** The image does not establish width, depth, activity or cause and does not demonstrate structural damage. The cracks may be confined to the finish, but this requires verification.

*Photo 06. Fine cracks in the render and surface weathering of timber.*

**Verification required:** Assign the location to an address, inspect at close range, measure and map the cracks, and check render adhesion, moisture and material junctions. If movement, debonding or other concerning features are found, refer the matter to a suitably qualified professional.

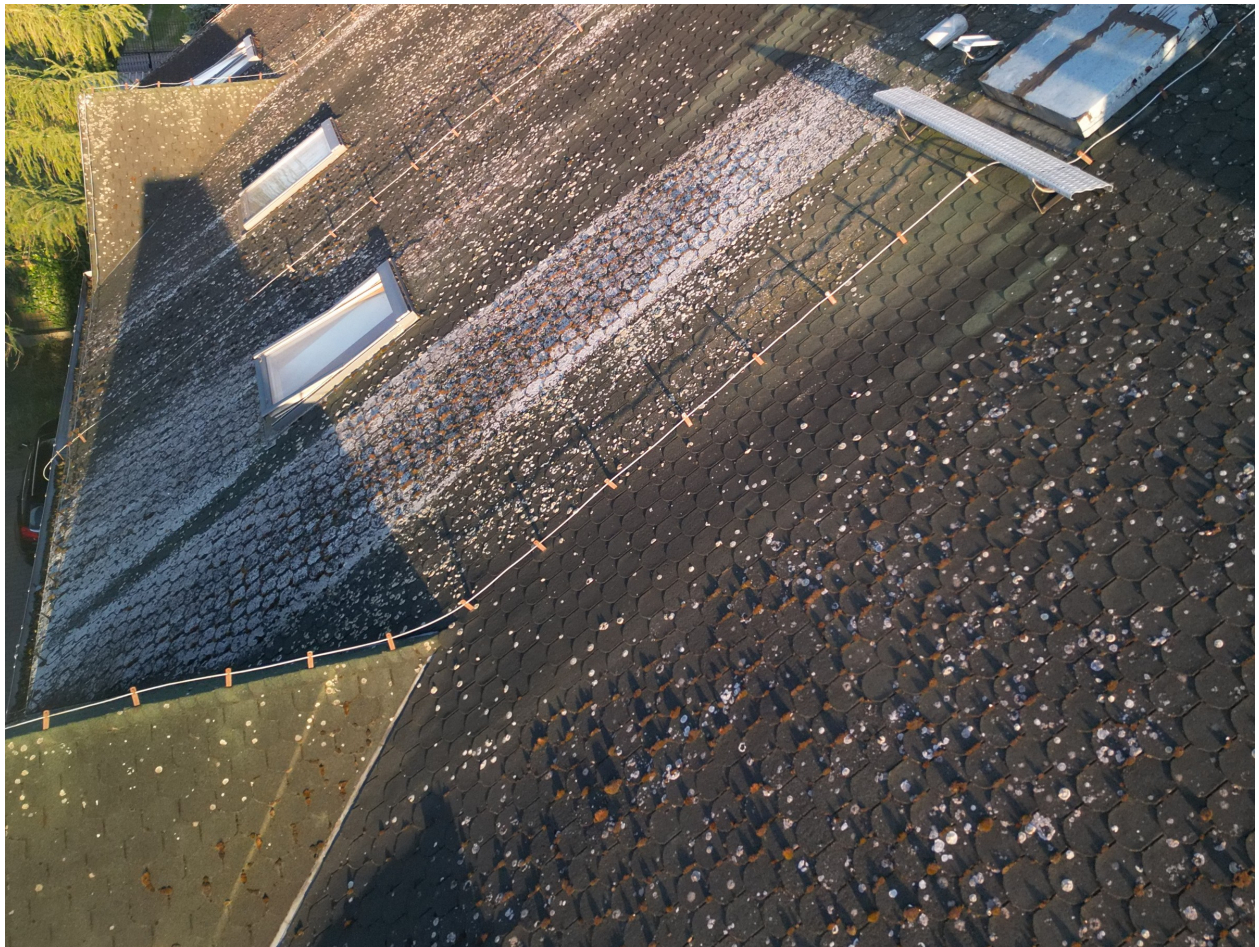
## PHOTOGRAPH 07 • SOURCE DJI\_0383.JPG

**Observation:** General views show differences in colour, texture and deposit intensity across areas of the roof planes.

**Possible implications:** These may arise from age, soiling, previous repairs, light or shadow and are not, by themselves, evidence of a defect.

*Photo 07. Extensive deposits and local variations in the appearance of the covering across several roof planes.*

**Verification required:** Prepare a roof-plane and repair-history map; identify at close range any loose, cracked or deformed elements or incorrect laps.

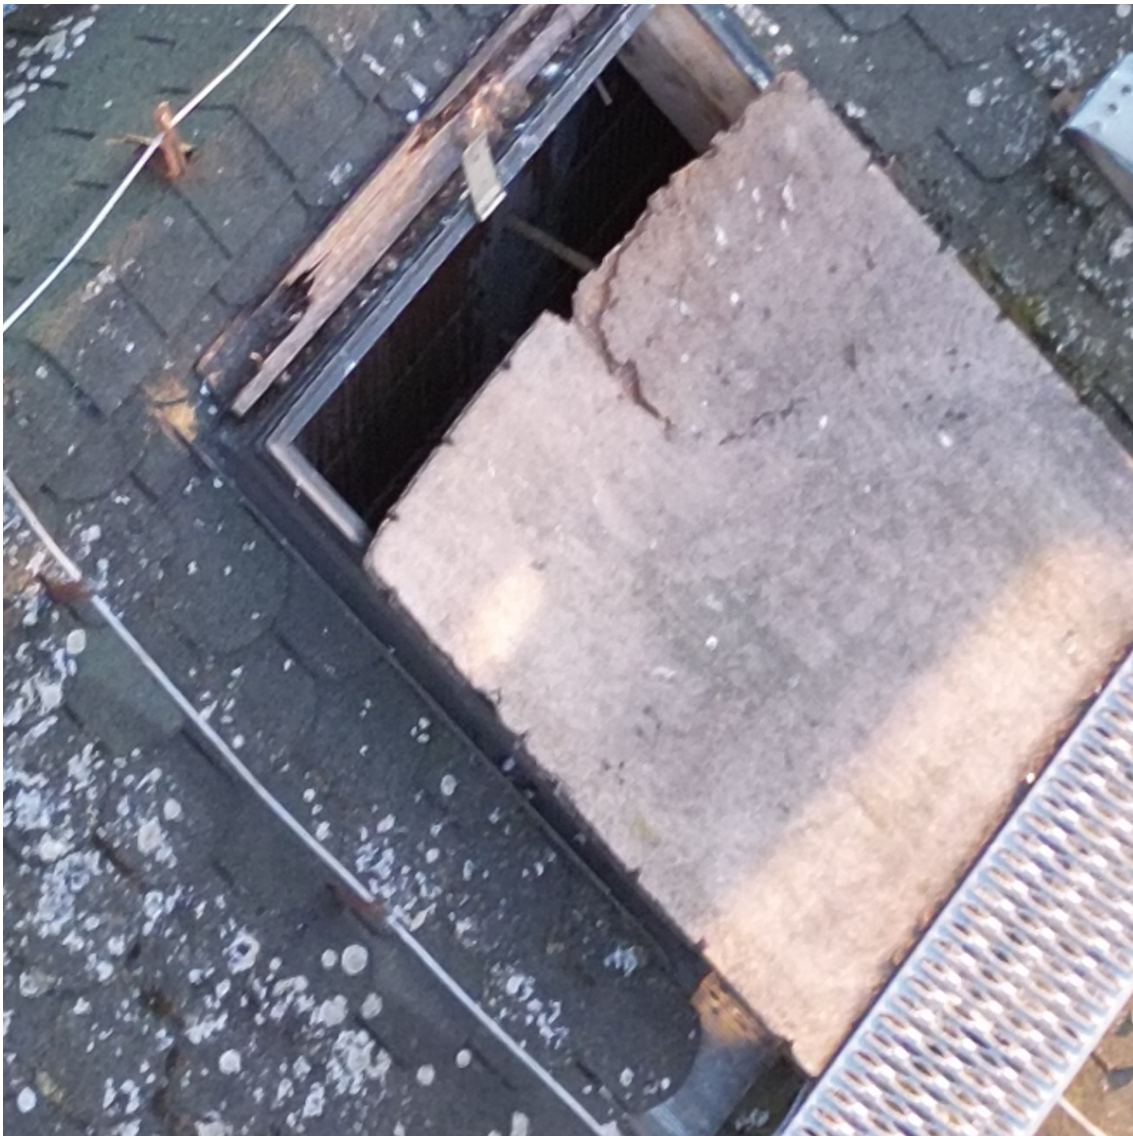
PHOTOGRAPH 08 • SOURCE DJI\_0386.JPG

**Observation:** The photograph shows a rectangular opening and a flat panel lying partly over or beside it. A line that may be a crack or fracture is visible on the panel. The resident states that the condition has not changed; this current status has not been independently verified.

**Possible implications:** If the account reflects the current condition, water ingress or movement of the element may be possible. The purpose of the opening, the method of securing the panel and the context in which the image was taken are unknown.

*Photo 08. A rectangular opening with a panel partly over or beside it; urgent verification is required.*

**Verification required:** Within 1-3 working days of receipt of the report, locate the element and confirm its current condition. Check the frame, fixings, closure, flashings, edges, internal signs of moisture and bird-dropping contamination. If the opening remains unprotected or the element is loose, provide immediate temporary mechanical and weatherproof protection.

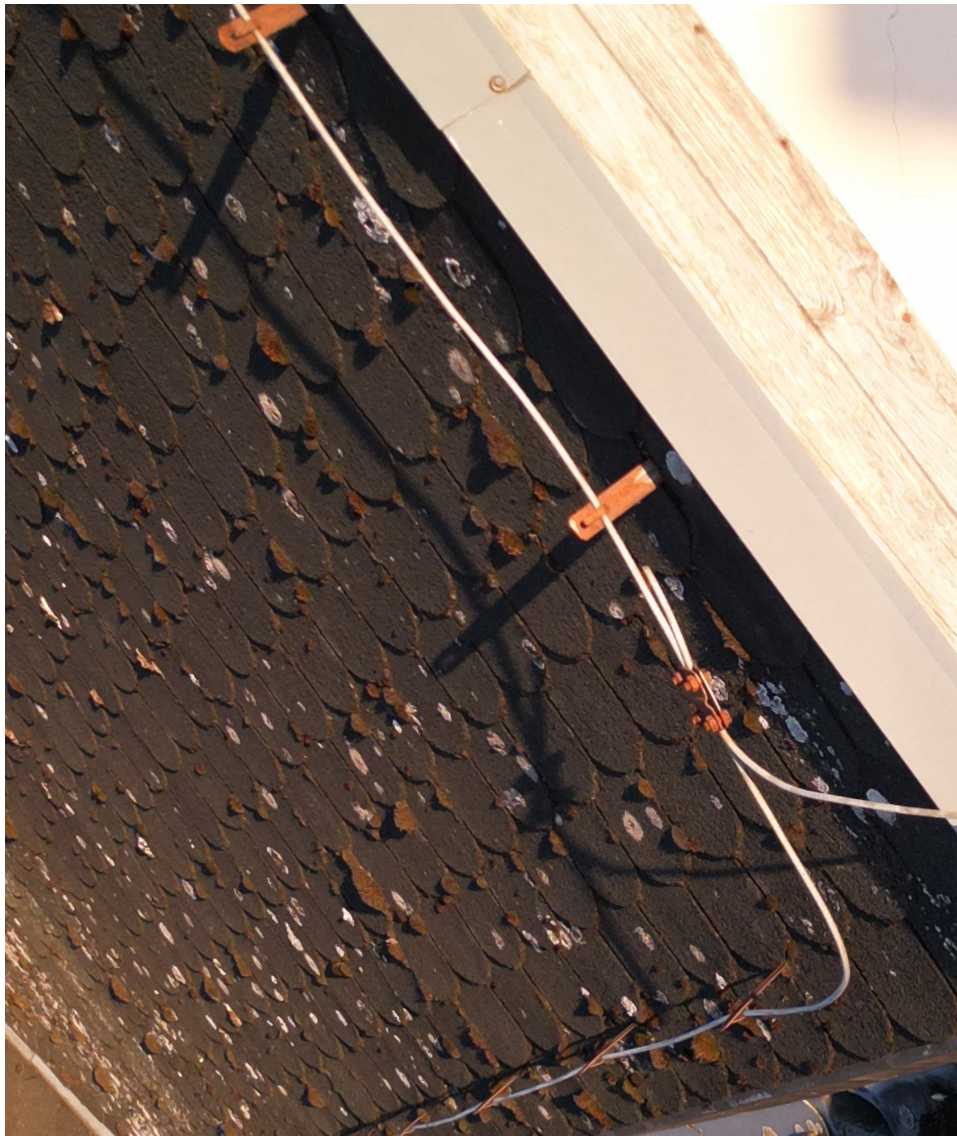
PHOTOGRAPH 09 • SOURCE DJI\_0395.JPG

**Possible implications:** A blockage cannot be confirmed, but the location warrants checks of flow capacity, falls and performance during rainfall.

*Photo 09. Material accumulated in the gutter and cables routed near the eaves.*
